HERITAGE

for ALL

COMPENDIUM

Heritage for All was a three-year research project with the goal of facilitating greater access to Canada's federal heritage buildings by providing guidance with which to develop standards and implement solutions appropriate in heritage contexts.

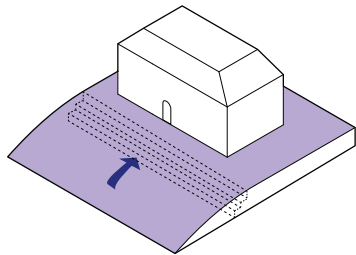
Raise grade to entrance level

Building up the ground surface to provide step-free access to an entrance.

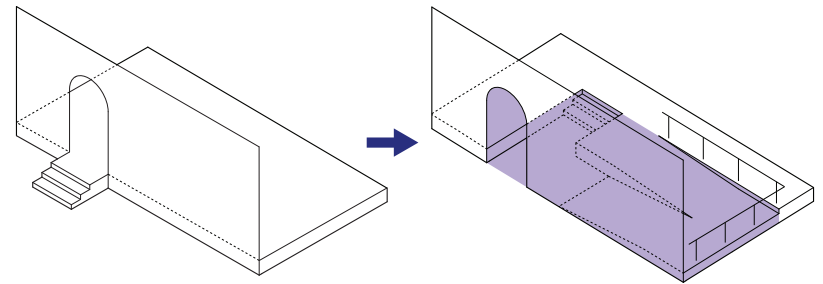
Move the door

Moving the door vertically to eliminate steps, e.g. by bringing it down to ground level.

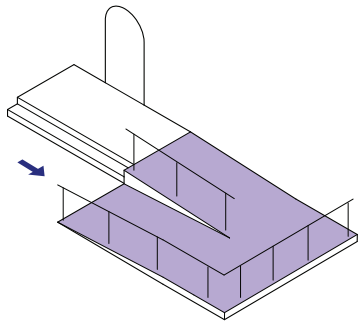
Above-grade ramp

Adding a ramp up to an entrance as a new architectural element employing compatible modern or period materials and details.

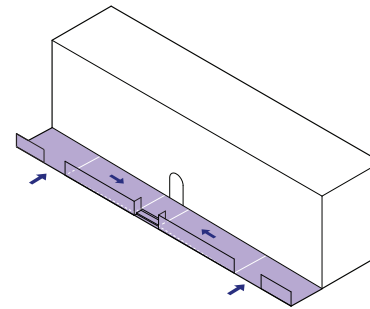
Low-profile/screened slopes/ramps

Adding a slope/ramp to an entrance with minimal visual impact.

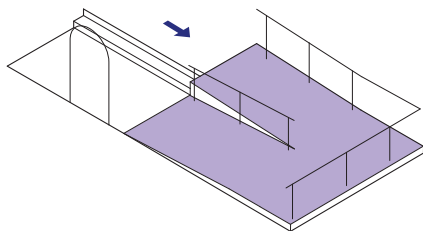
Below-grade ramp

Adding a ramp down to a new or existing entrance as a new architectural element employing compatible modern or period materials and details.

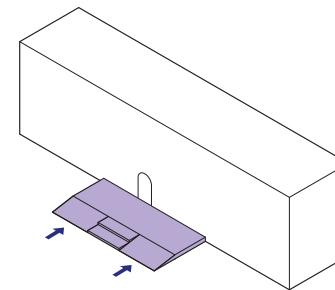
Integrated ramp/slopes

Redeveloping stairs to incorporate ramps or slopes as part of a unified element.

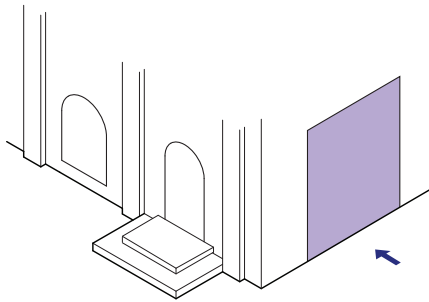
New primary entrance

Using an existing, alternative historic entrance or adding a new entrance to provide step-free access for all users.

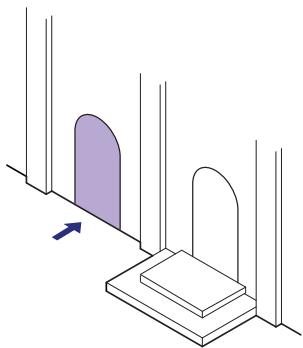
Accessible secondary entrance

Adding or adapting a non-primary entrance to provide access.

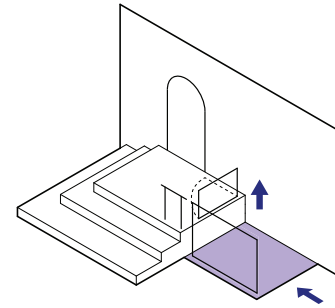
Low-profile exterior lifts

Adding a high-quality exterior lift with features and details that visually recede or compliment the heritage building.

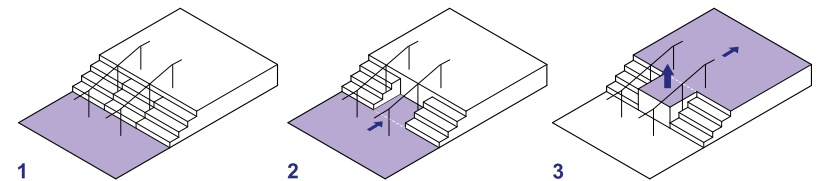
Concealed platform lift

Adding a concealed lift to overcome historic stairs. Concealed platform lifts work as stairs when not in use but transform into a lift when needed.

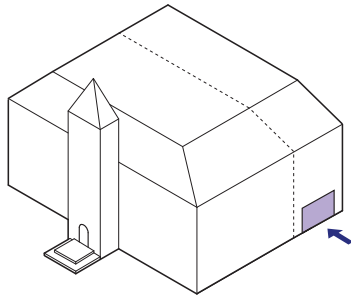
Access through addition

Providing access through an accessible extension that may be limited to an entrance or include new programmatic space.

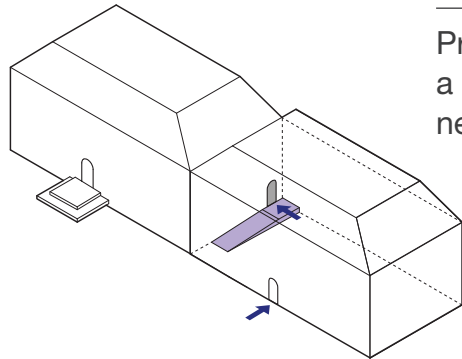
Access through adjacent building

Providing access through a separate existing or new building.

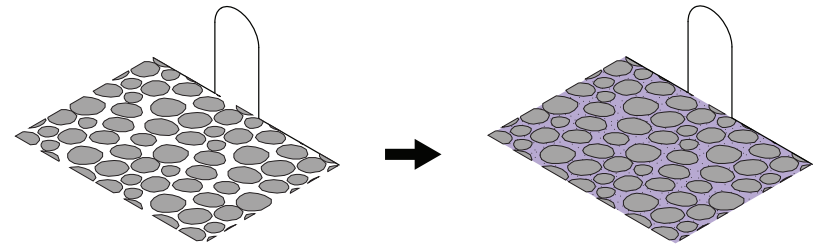
Consolidation of ground surfaces

Re-setting unit ground surfaces on solid substrates or augmenting granular ground surfaces to provide firm, level paths.

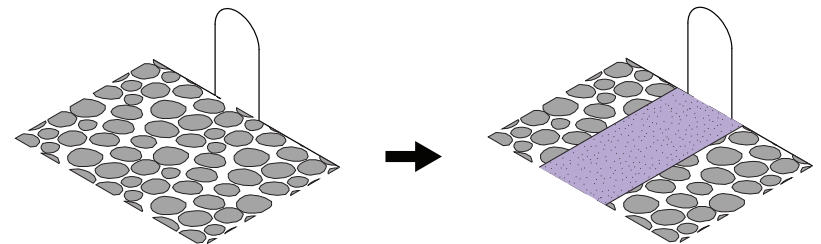
Access paths

Providing dedicated paths with more accessible surface characteristics within a larger path or landscape.

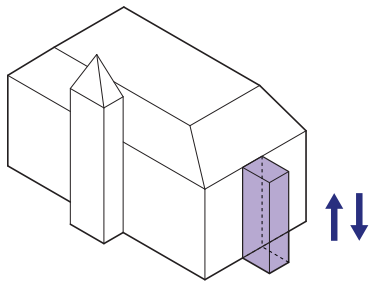
Vertical circulation outside the historic envelope

The addition of stair/ elevator towers or new amenity structures with ramps or elevators.

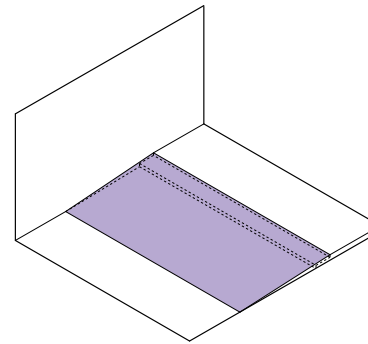
Sloping floors

The modification of interior floors to eliminate steps.

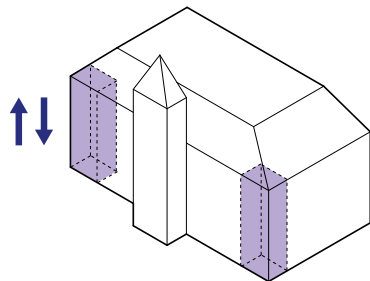
Inserted vertical circulation

The insertion of new stairs, ramps, and elevators or lifts within the historic envelope.

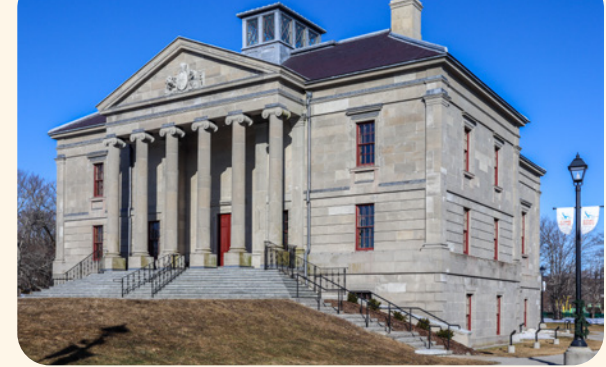
The front portico was conserved and the public entrance relocated.

A relatively small floor plan precluded the insertion of an elevator, and it was decided early on that a lift would be added in a corner of the "T" and a lower side door would be the main entrance.

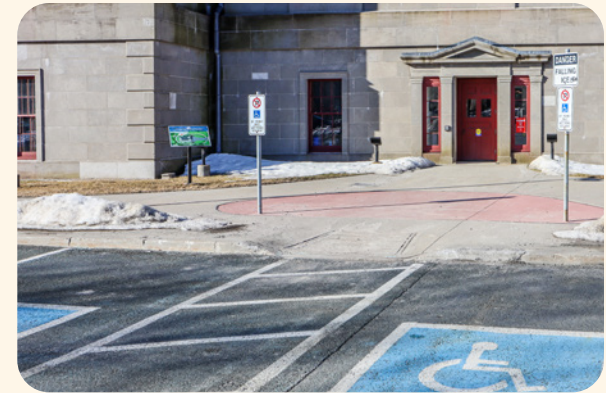
An existing side door, near accessible parking, is now the entrance for all.

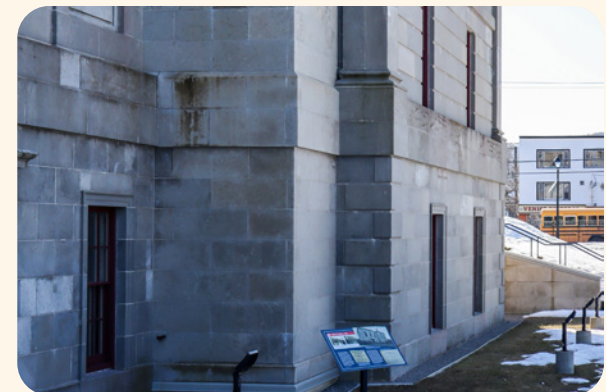
The lift (left of centre) uses materials of the existing building with subtle modern details.

Programming was oriented to this entrance, with tours progressing to the lift and nearby staircase where visitors go together to the main floor. A passage was opened between the left and right galleries to provide step-free access to the entire upper floor. On the exterior, the lift is clad in stone that matches the heritage building.

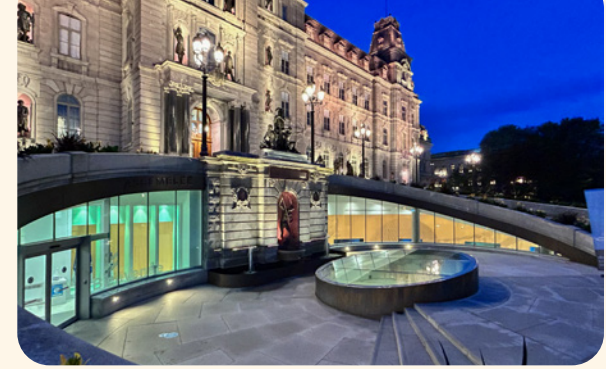
New facilities were added below historic stairs with minimal visual impact.

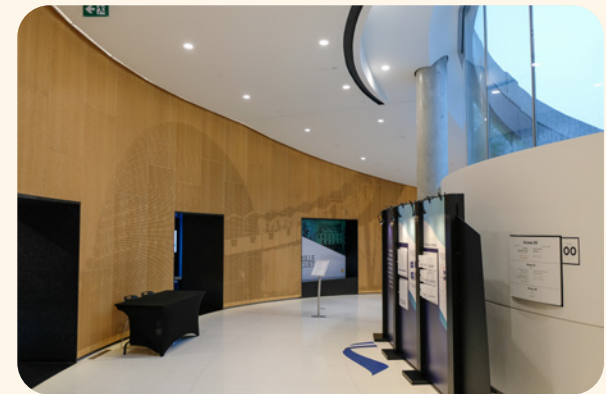
A spiral ramp under the stairs descends to visitor amenities.

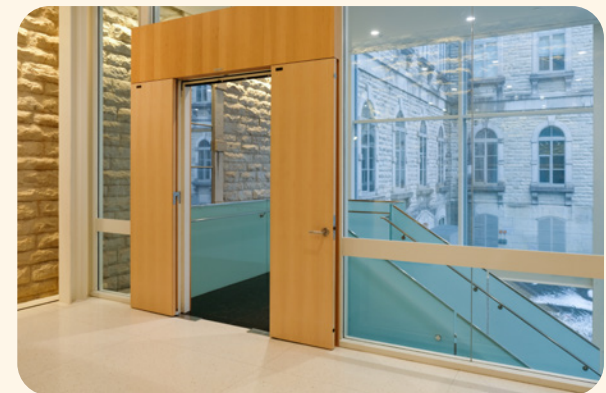
A new stair and elevator were inserted in the building's courtyard.

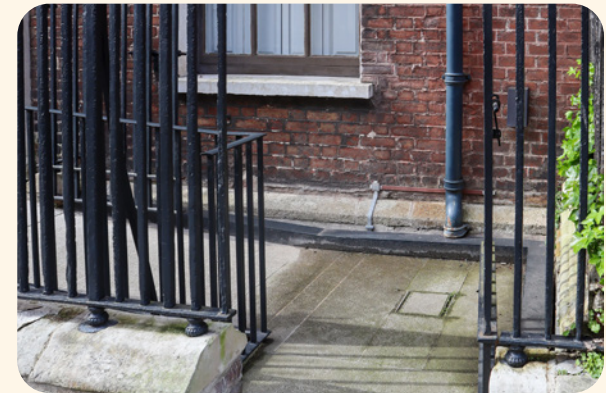
A fence and low wall were cut to provide ramp access to the front door.

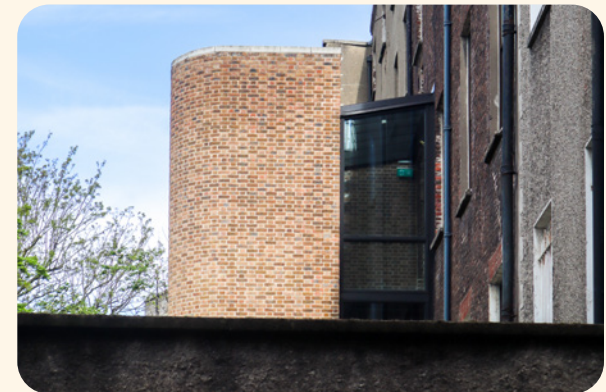
A rear elevator reaches all public levels but not upper staff areas.

At the rear, a new structure provides step-free entry, vertical circulation, and washroom facilities. Window openings were used to connect the addition to the house. While modern in detail, the addition makes use of materials that match but remain distinct from the heritage building. The museum's website provides pre-visit information and staff are trained in universal access.

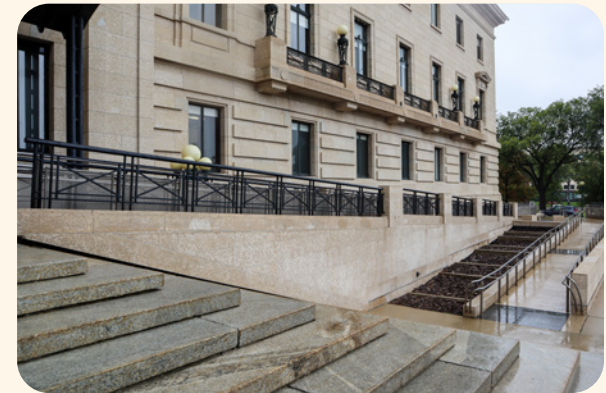
The ramp extends over the historic stairs without touching them.

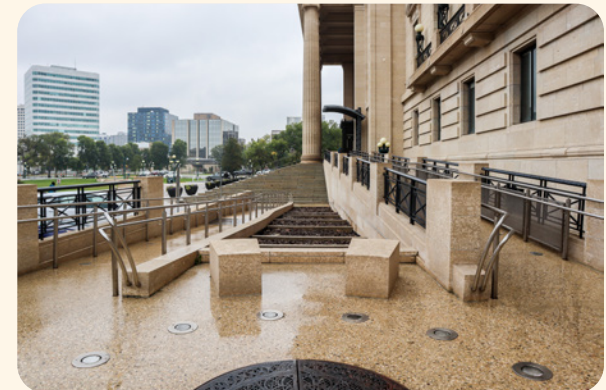
The journey for all visitors begins and ends at the same place.

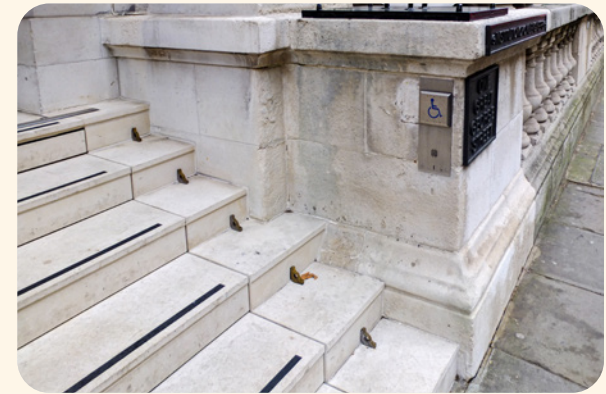
A call button on the right alerts building attendants who prepare the lift.

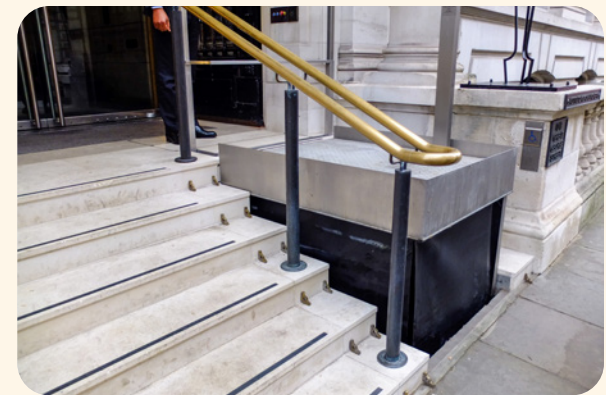
One side of the steps retracts and a platform lift rises from below.

- The width of the stairs permitted the installation of a hidden lift while maintaining functional use of the adjacent steps.
- Attentive, trained staff enable access with minimum delay.
- Impact on the building is minimized by using stone from the original steps to clad the lift.

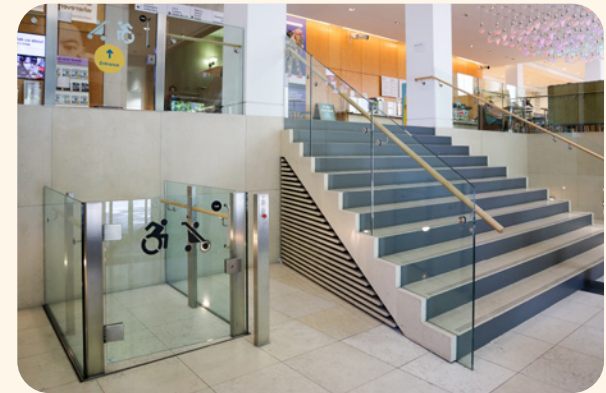
A platform lift is collocated with the entrance stair inside the front doors.

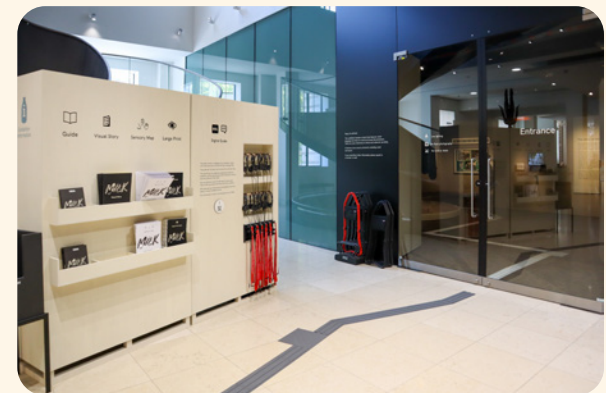
A kiosk near the entrance provides auditory, visual, and sensory aids.

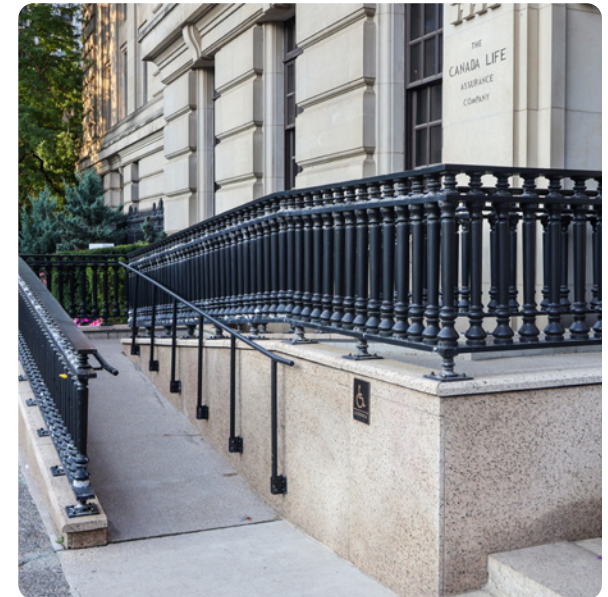
A ramp in a compatible style was added to the Sun Life Building, Toronto, Ontario
